NPIC/R-180/64

SUSPECT ROCKET TEST FACILITY, KRASNOYARSK, USSR

Approved For Releas (2003/08 (2002 FTA-RDP78B04560A002000010027-4
NPIC/R-180/64
March 1964
PHOTOGRAPHIC INTERPRETATION REPORT

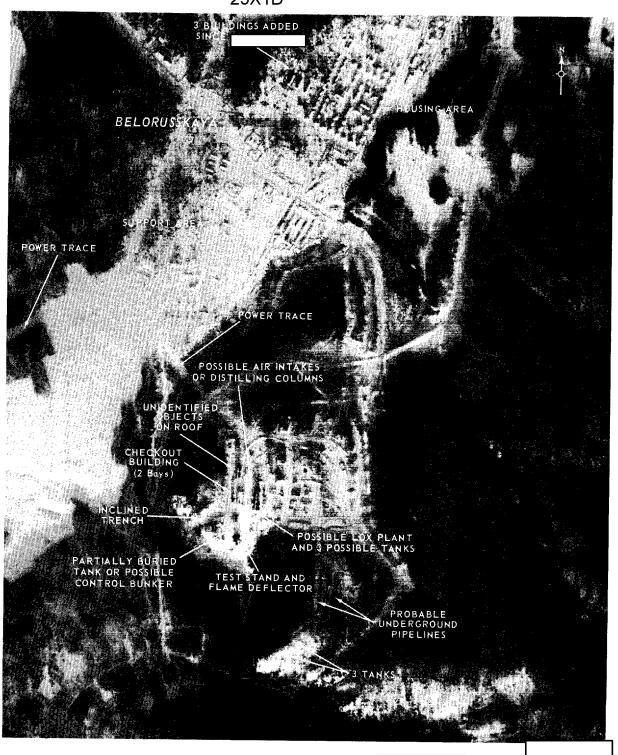
FIGURE 2. SUSPECT ROCKET TEST FACILITY,

25X1A	A SAM site is located 4 nm northeast of the suspect test facility. The facility occupies approximately 95 acres and is surrounded by a fence (Figures 2 and 3). This site is a dissected plateau; the	usskaya, have not changed significantly since The facility and its components are served by a good road and an elaborate rail system which branch from the Krasnoyarsk-Dodonovo road and rail systems.	25X1D
	SUSPECT ROCKE	T TEST FACILITY	
25X1D 25X1D	No major changes in this installation have been observed since photography of However, many features which were only faintly discernible can now be identified and analyzed. Item numbers are keyed to Figure 3. The test stand has been modified by the addition of a structure which projects from the	This may be the beginning of a structure similar to the one attached to the stand at the Perm Rocket Test Facility. 2/ Although newly identified, this addition may have been in existence for a considerable length of time and eluded detection because of its small size and the poor quality of photographic coverage prior to	25X1D

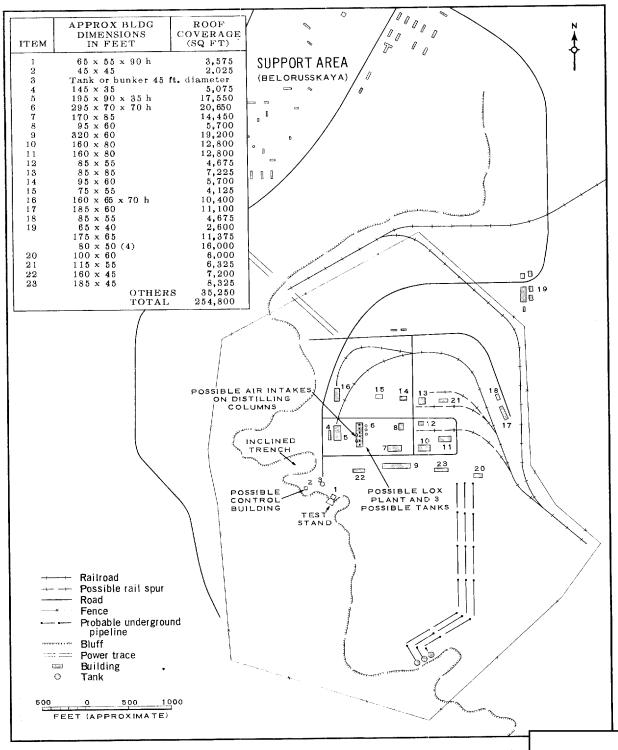
FIGURE 3. COMPONENTS OF SUSPECT ROCKET TEST FACILITY, KRASNOYARSK, USSR. L

Six large circular objects, possibly ventilators, are discernible on the roof of one of the buildings (item 6). This building is very large, and its association with the suspect test facility suggests that it may be a LOX plant. Moreover, the dimensions of this possible LOX plant approximate those of known Soviet LOX plants. 3/ Three circular objects adjacent to the possible LOX plant on the east side may be tanks employed in the processing of liquid oxygen and two circular objects adjacent to

it on the west side may be air intakes or distilling columns.

The previously identified probable control building 1/ is now interpreted as a possible control building (item 2); it may also be an observation post or camera station. This building is approximately 400 feet from the test stand.

compound. These scars and tanks probably constitute a fuel supply system with pipelines leading from the tanks to the test stand. These facilities were also present but not identified on previous coverage. A partially buried circular structure (item 3) immediately north-northwest of the test stand could be either a control bunker or a storage tank for fuel or water. A rail-served building (item 16) is unusually tall (70 feet) and has four unidentified objects on the roof. An inclined trench, which has been visible since ______ is located northwest of the test stand and may be the site of a flame deflector for a second test stand.

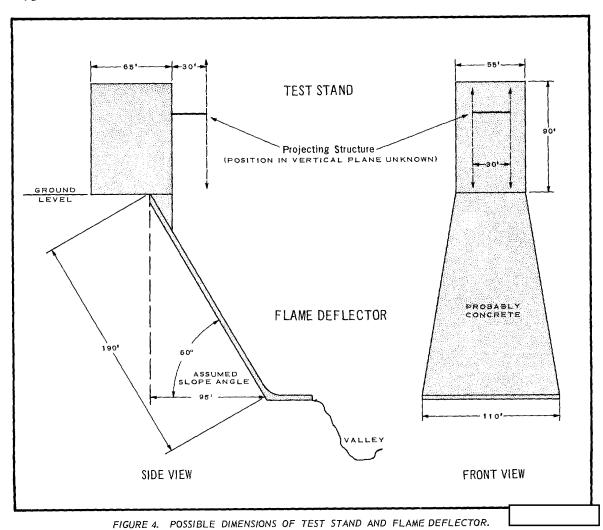
south side of the stand and is apparently centered over the flame deflector (Figures 4 and 5).	05745	20/(12
		25X1D	
	Declassification Re	eview by NIMA / DoD
